Kyawa OC Services

Property Inspection Report

Inspection date: Friday, April 12, 2019

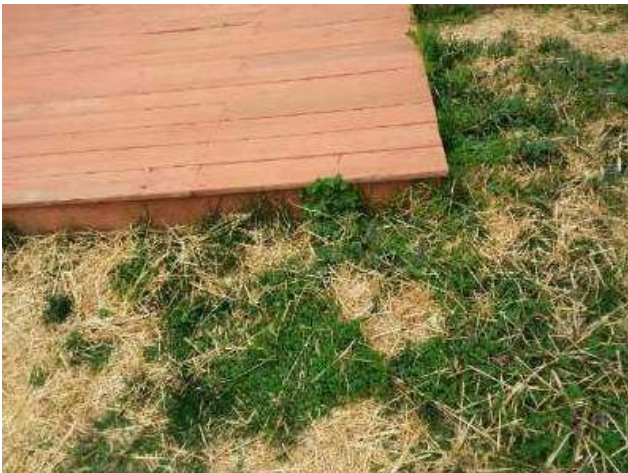
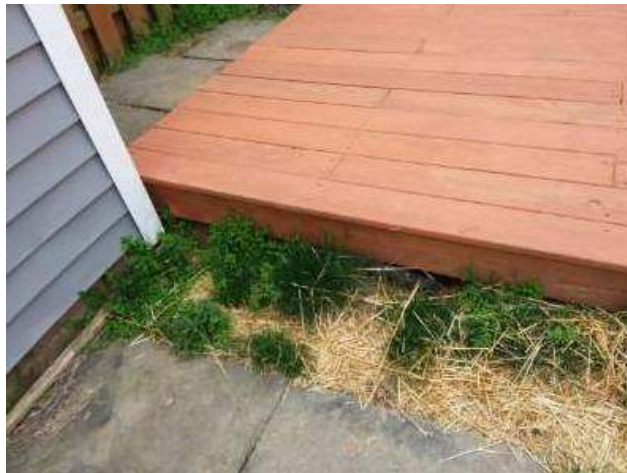
2) Repair/Maintain - Soil was in contact with one or more wooden deck, porch or balcony components. This is a conducive condition for wood destroying organisms. Even if posts are made of treated wood, the cut ends below soil may not have been field treated. Recommend grading soil or repairing as necessary to prevent wood-soil contact.

Photo 2-1 Soil in contact with decking structure.

Photo 2-2 Soil in contact with decking structure.

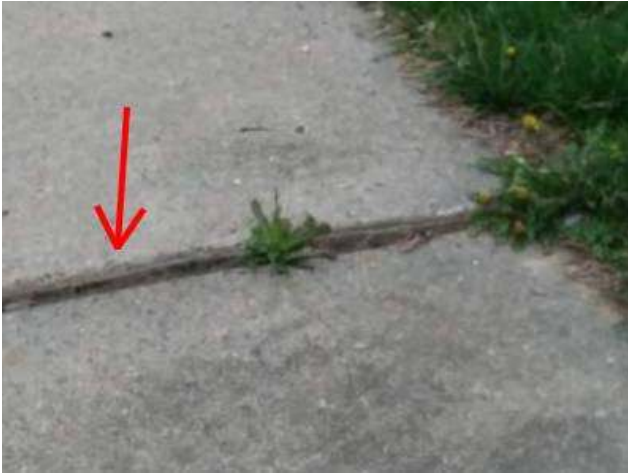
3) Comment - Cracks, holes, settlement, heaving and/or deterioration resulting in trip hazards were found in the sidewalks or patios. For safety reasons, recommend that a qualified contractor repair as necessary to eliminate trip hazards.

Photo 3-1 Trip hazard on common area sidewalk.

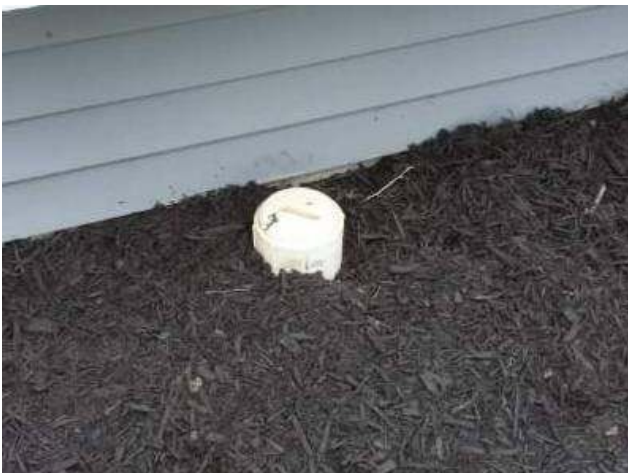
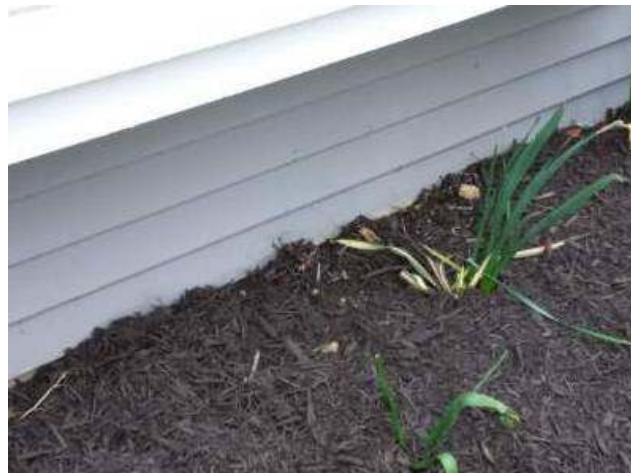
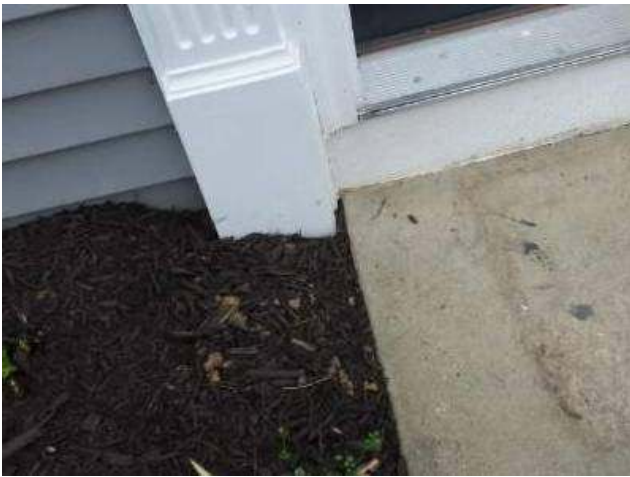
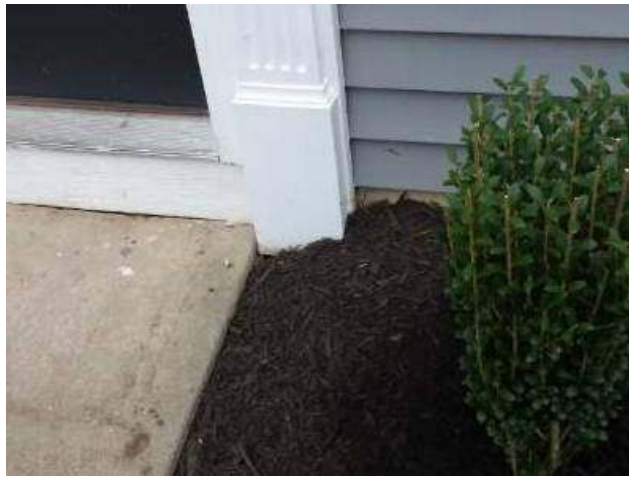
4) Repair/Maintain - Soil was in contact with or less than 6 inches from siding or trim. Regardless of what material is used for siding, it should not be in contact with the soil. If made of wood, siding or trim will eventually rot. For other materials, ground or surface water can infiltrate siding or trim and cause damage to the wall structure. Wood-destroying insects are likely to infest and damage the wall structure. This is a conducive condition for wood-destroying organisms. Recommend grading or removing soil as necessary to maintain a 6-inch clearance. Note that damage from fungal rot and/or insects may be found when soil is removed, and repairs may be necessary.

Photo 4-1 Soil in contact with siding.

Photo 4-2 Soil in contact with siding.

Photo 4-3 Soil in contact with trim.

Photo 4-4 Soil in contact with trim.

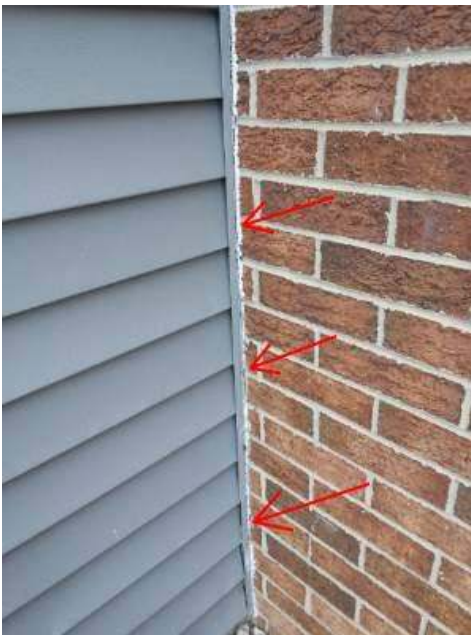
5) Maintain - Caulk was deteriorated in some areas. For example, Siding to brick. Recommend that a qualified person renew or install caulk as necessary. Where gaps are wider than 1/4 inch, an appropriate material other than caulk should be used. For more information, visit:

Caulk deteriorated at exterior wall where it meets unit 126.

Photo 5-1 Caulking degraded; need to be re-caulked.

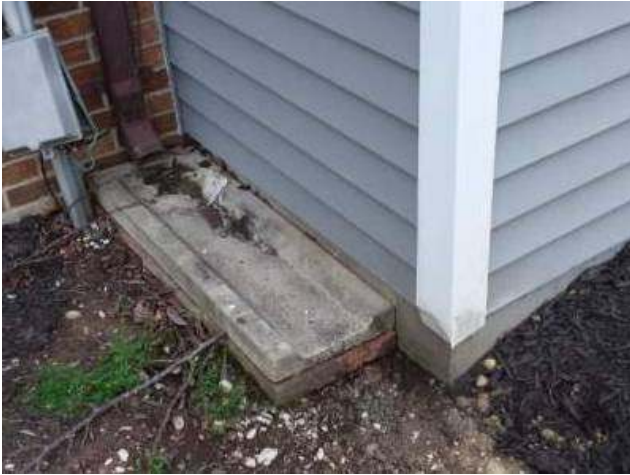
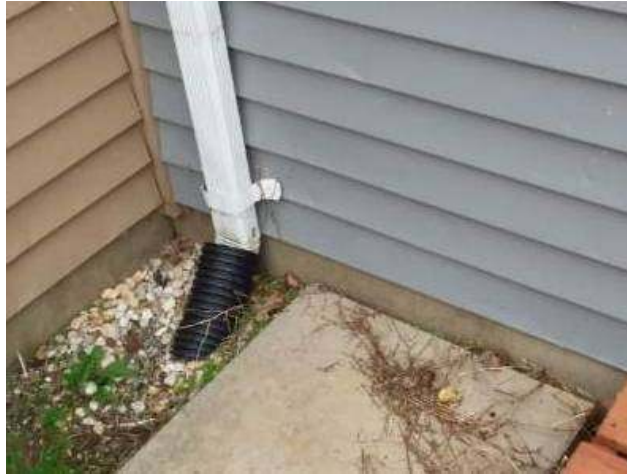
6) Repair/Maintain - Extensions such as splash blocks or drain pipes for one or more downspouts were missing. Water can accumulate around the building foundation or inside crawl spaces or basements as a result. Recommend that a qualified person install, replace or repair extensions as necessary so rainwater drains away from the structure.

Photo 6-1 Need to extend downspout drain.

Photo 6-2 Buried downspout line-destination unknown.

Extend drains away from house

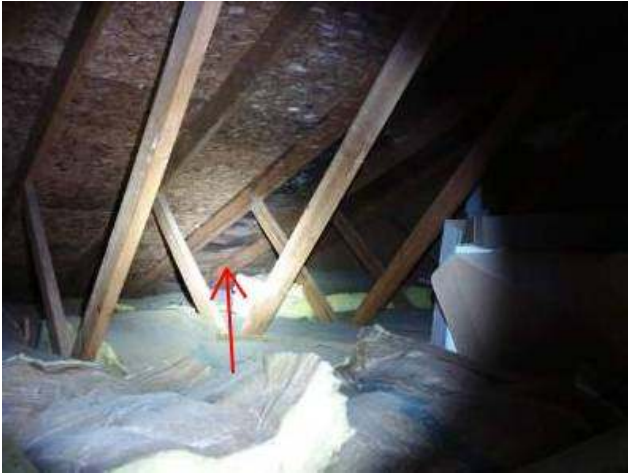
8) Monitor, Comment - Evidence of previous water infiltration on roof sheathing at front of house.

Photo 8-1 Evidence of previous water leak.

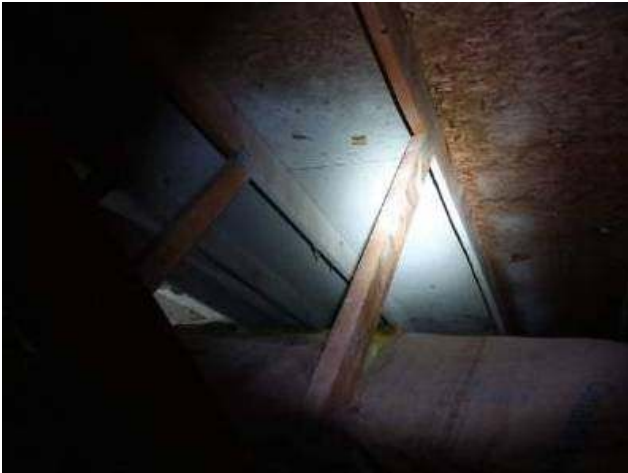
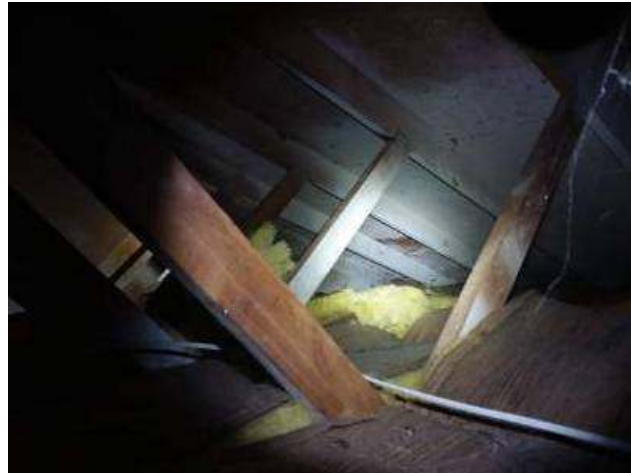
9) **Monitor, Comment** - Evidence of paint on sheathing in attic at rear of house-possible repair of organic growth.

Photo 9-1 Evidence of repair; may be treatment for organic growth.

Photo 9-2 Evidence of repair; may be treatment for organic growth.

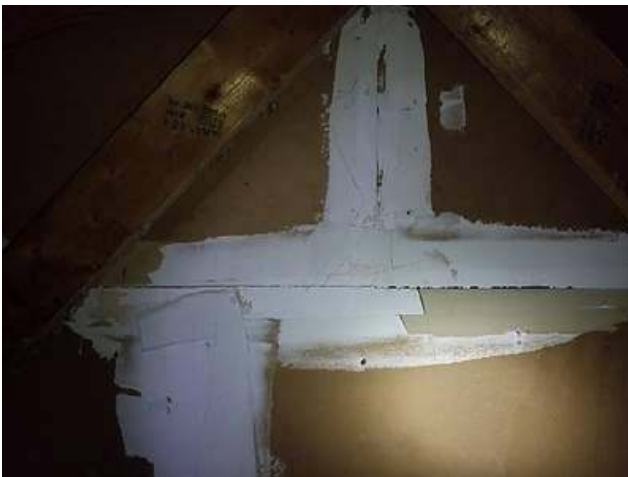
Photo 10-1

10) **Comment** - Evidence of repair to party wall in attic.

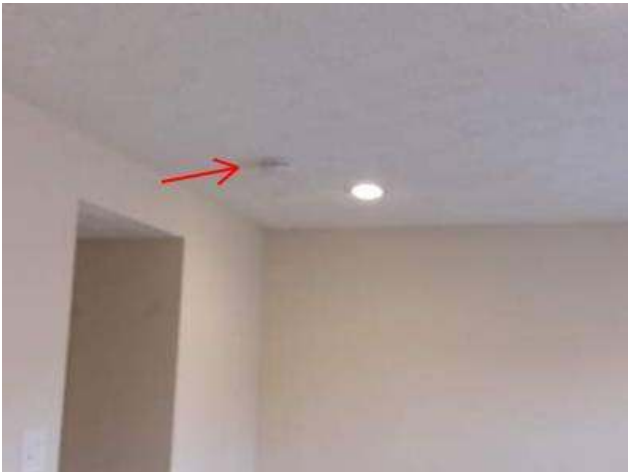
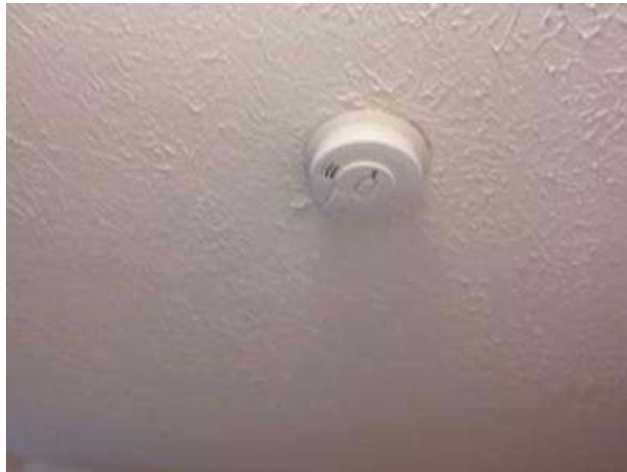
11) Safety, Repair/Replace - Smoke alarms were missing from one or more bedrooms. Smoke alarms should be installed as necessary so a functioning alarm exists in each hallway leading to bedrooms, in each bedroom and on each level. For more information, visit:

One smoke alarm was present on each floor. The 1st floor smoke detector was located in the family room and was a sealed 10 year battery non-hardwired type. The 2nd floor smoke detector was located at the top of the stairs and was a hardwired type. They were not interconnected. No smoke detectors in any bedrooms.

Photo 11-1 1st floor 10-year sealed battery non-hardwired smoke detector.

Photo 11-2 2nd floor hardwired smoke detector.

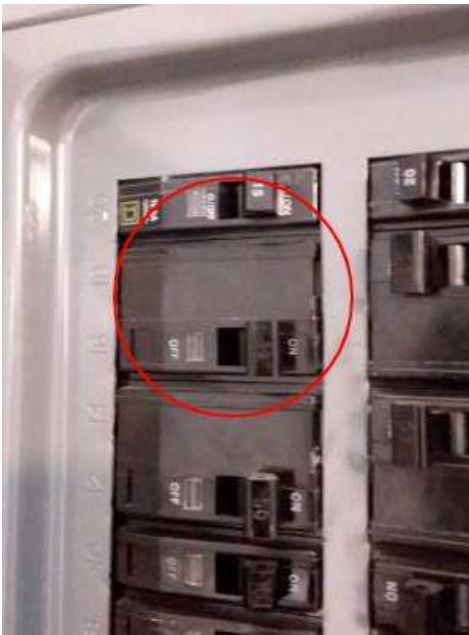
12) Safety, Repair/Replace - Outdoor condenser has max breaker of 20 Amps-panel has 30 Amp.

Photo 12-1 30 AMP breaker for HVAC compressor. Compressor rated for 20 AMP.

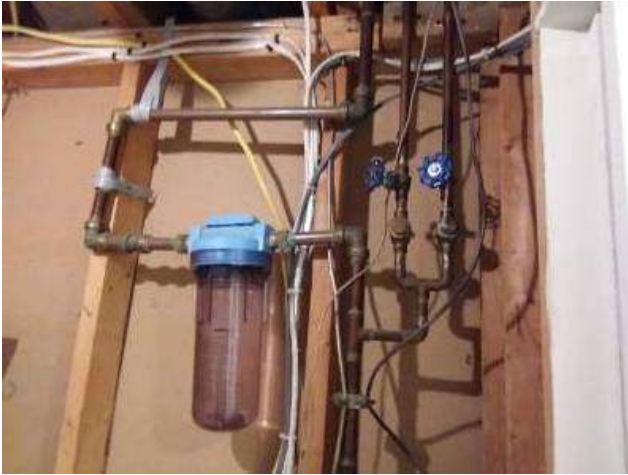
Photo 14-1

14) Evaluate - A water filtration system was installed on the premises. These are specialty systems and are excluded from this inspection. Comments in this report related to this system are made as a courtesy only and are not meant to be a substitute for a full evaluation by a qualified specialist. Filter cartridges typically need replacing periodically. Cleaning and other maintenance may also be needed. Recommend consulting with the property owner about this system to determine its condition, required maintenance, age, expected remaining life, etc. For more information, visit:

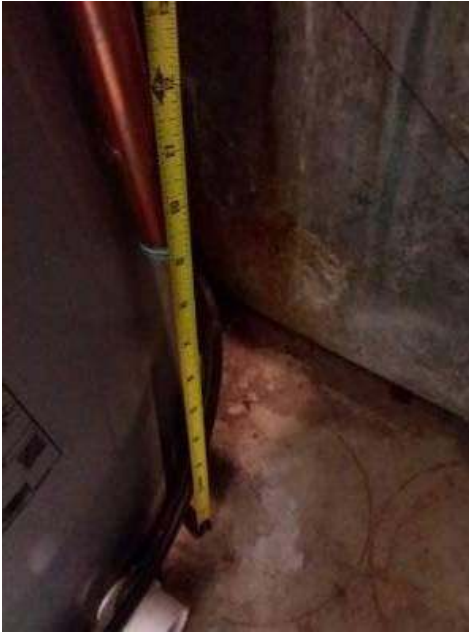
Photo 15-1

15) Repair/Replace - TPR valve drain pipe terminated >6" from the floor; recommend replacement.

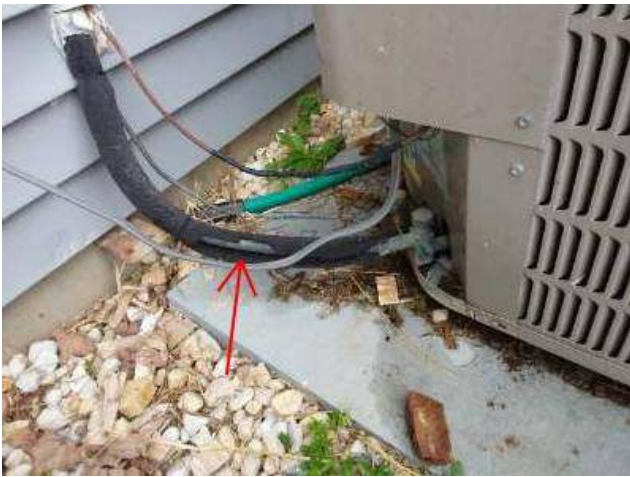
18) **Repair/Replace** - Insulation on the heat pump or air conditioning condensing unit's refrigerant lines was deteriorated or missing in some areas. This may result in reduced efficiency and increased energy costs. Recommend that a qualified person replace or install insulation as necessary.

Photo 18-1 Degraded HVAC line insulation needs replacing.

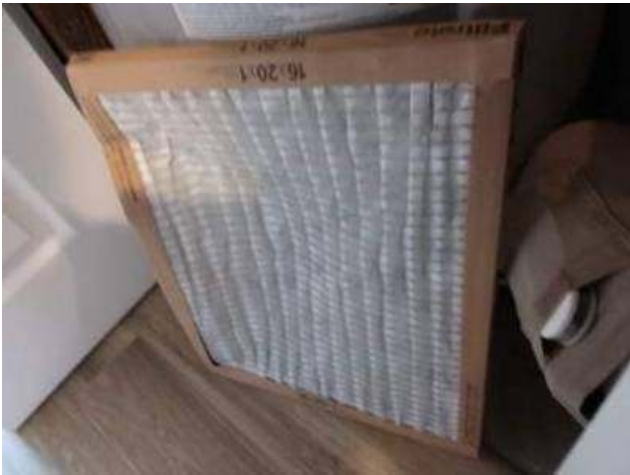
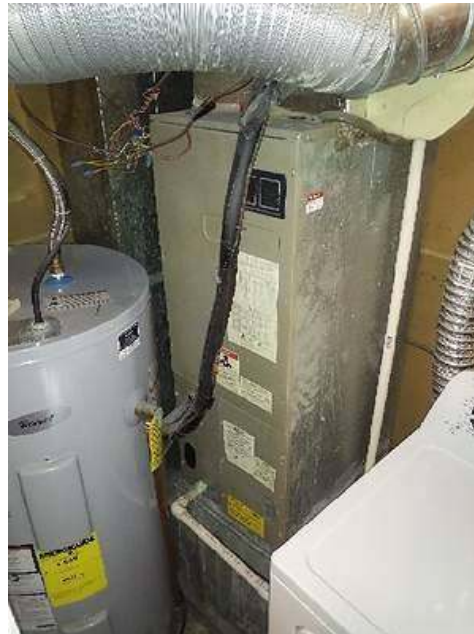
19) Repair/Maintain - The water heater is installed too close to the air handler preventing access to the filter slot. Filter must be forced in to install. This has limited service to the unit.

Photo 19-1 New filter ruined during install/removal. No clearance to filter slot resulting from installation of water heater too close to air handler.

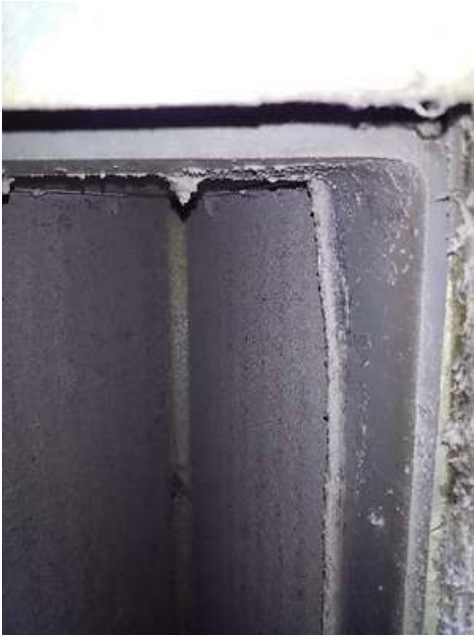
Photo 20-1

20) Repair/Maintain - Coils in air handler were dirty and in need of service. Recommend a complete service by a qualified HVAC contractor.

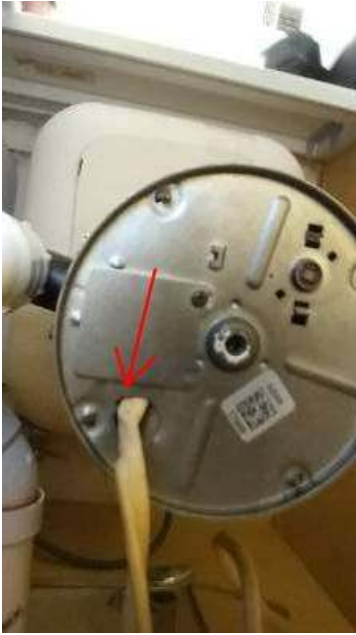
23) Safety, Repair/Replace - Electrical wiring for the under-sink food disposal was substandard. Non-metallic sheathed wiring was exposed and subject to damage. The wiring can be damaged by repeated bending or contact with sharp objects. BX-armored conduit should be installed to protect wiring, or a flexible appliance cable should be installed. This is a potential shock hazard. Recommend that a qualified contractor repair per standard building practices.

Photo 23-1 Missing wire clamp.

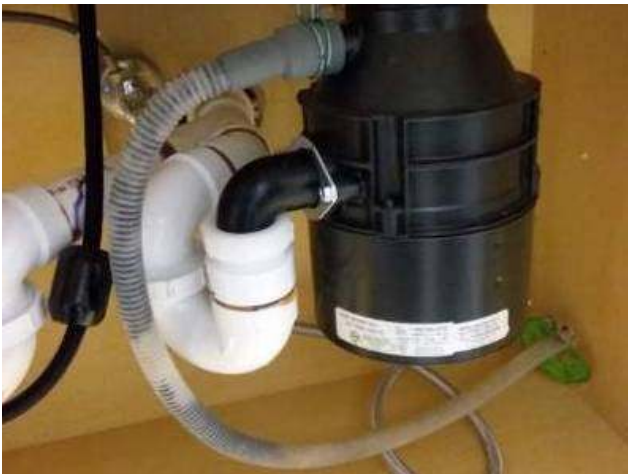
25) Repair/Replace, Evaluate - The inspector was unable to determine if the dishwasher's drain line had a high loop or air gap (e.g. drain line not visible). A high loop is created by routing the drain line up to the bottom surface of the counter top above and securely fastening it to that surface. An air gap is a device that makes the drain line non-continuous. Both of these prevent waste-water backflow from entering the dishwasher, and possibly flooding out of the dishwasher if/when a siphon occurs. Some newer dishwashers have these devices built in. Recommend reviewing the dishwasher's installation instructions, consulting with the property owner and/or having a qualified contractor evaluate further to determine if a high loop and air gap are installed or needed. If not installed, and none is built into the dishwasher, then recommend that a qualified contractor install a high loop and air gap per standard building practices.

Photo 25-1 No evidence of high loop for dishwasher.

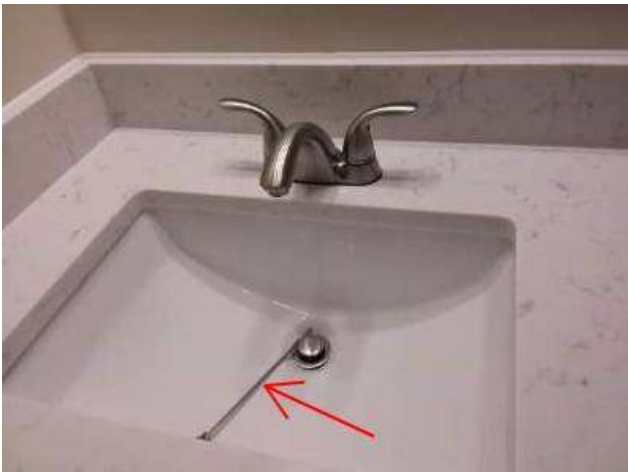
29) - Sink stopper not operable in 2nd floor bathroom. Pull rod not connected to strap.

Photo 29-1 Sink stopper not connected.

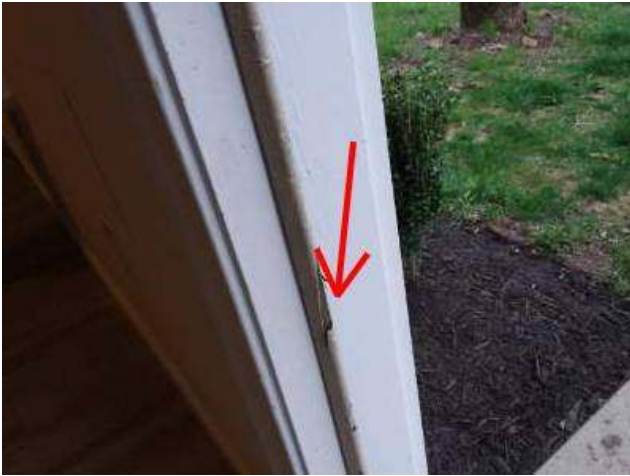
30) Comment - One or more exterior doors had minor damage and/or deterioration. Although serviceable, the client may wish to repair or replace such doors for appearances' sake. Weather strip needs repair at front entry.

Photo 30-1 Damaged weather seal; needs replacement.

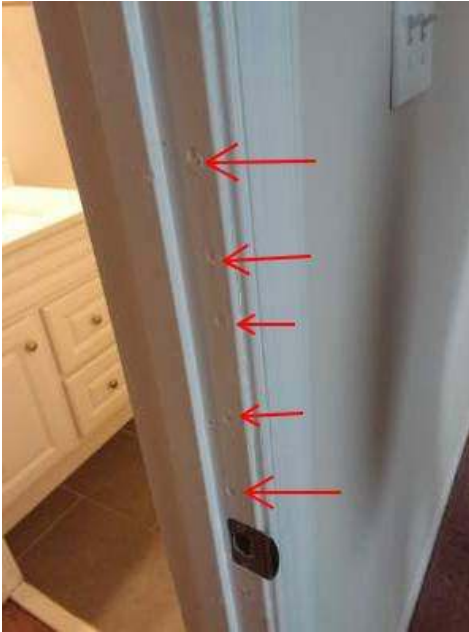
Photo 31-1

31) Comment - Evidence of repair to door frame in bedroom.

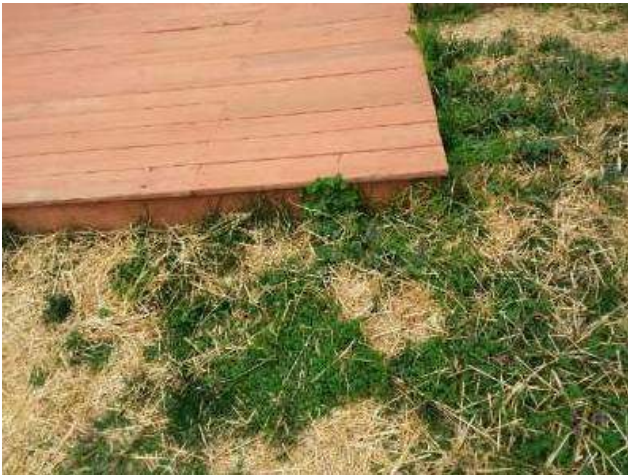
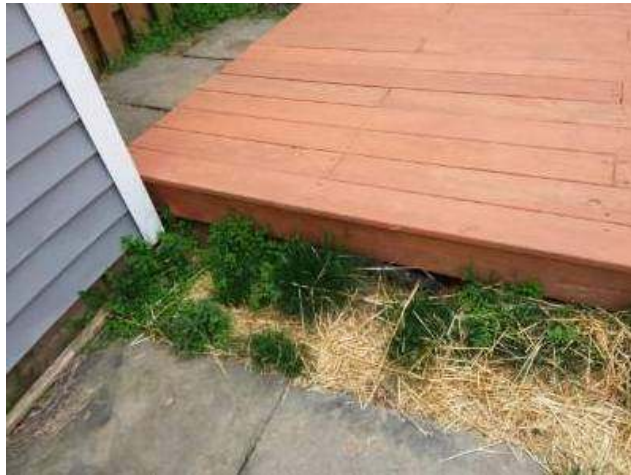
All areas of the deck substructure were inaccessible due to limited space below. These areas couldn't be evaluated and are excluded from the inspection.

Photo 2-1 Soil in contact with decking structure.

Photo 2-2 Soil in contact with decking structure.

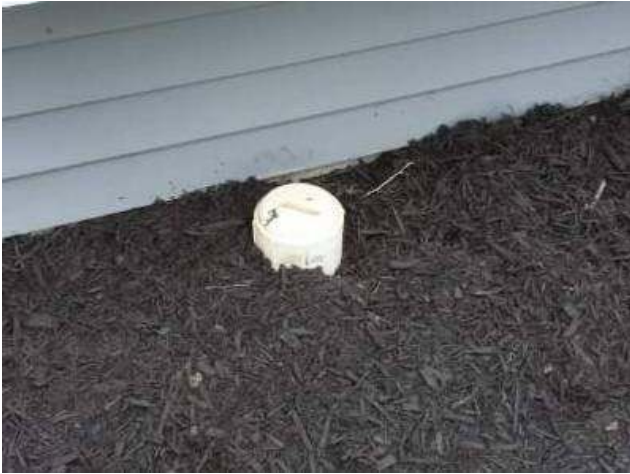
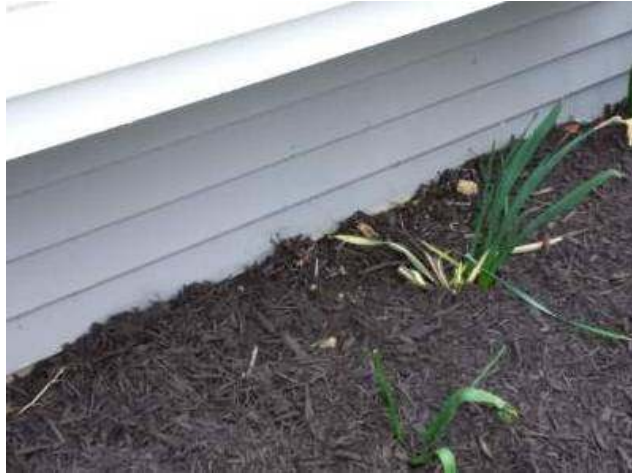
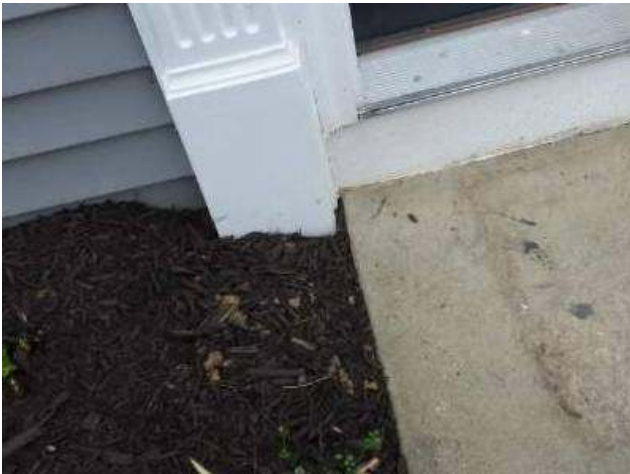
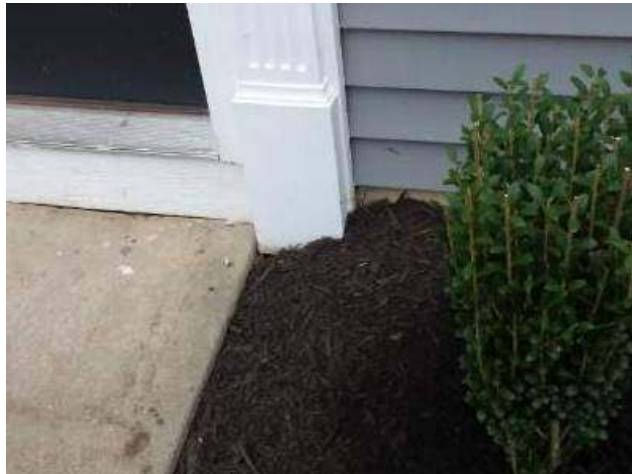
4) **Repair/Maintain** - Soil was in contact with or less than 6 inches from siding or trim. Regardless of what material is used for siding, it should not be in contact with the soil. If made of wood, siding or trim will eventually rot. For other materials, ground or surface water can infiltrate siding or trim and cause damage to the wall structure. Wood-destroying insects are likely to infest and damage the wall structure. This is a conducive condition for wood-destroying organisms. Recommend grading or removing soil as necessary to maintain a 6-inch clearance. Note that damage from fungal rot and/or insects may be found when soil is removed, and repairs may be necessary.

Photo 4-1 Soil in contact with siding.

Photo 4-2 Soil in contact with siding.

Photo 4-3 Soil in contact with trim.

Photo 4-4 Soil in contact with trim.

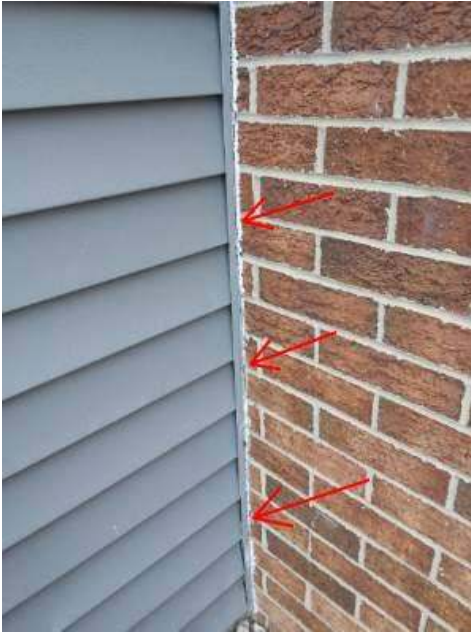
5) Maintain - Caulk was deteriorated in some areas. For example, Siding to brick. Recommend that a qualified person renew or install caulk as necessary. Where gaps are wider than 1/4 inch, an appropriate material other than caulk should be used. For more information, visit: <http://www.reporthost.com/?CAULK>

Caulk deteriorated at exterior wall where it meets unit 126.

Photo 5-1 Caulking degraded; need to be re-caulked.

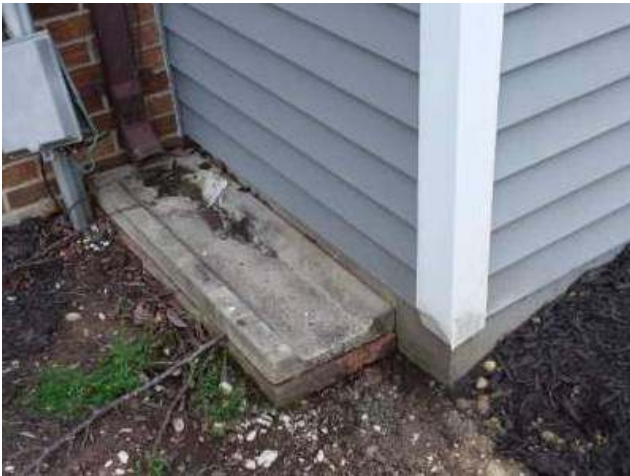
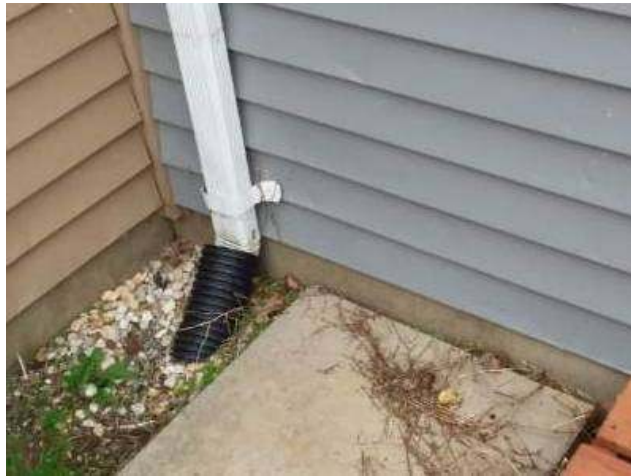
Photo 6-1 Need to extend downspout drain.

Photo 6-2 Buried downspout line-destination unknown.

Extend drains away from house

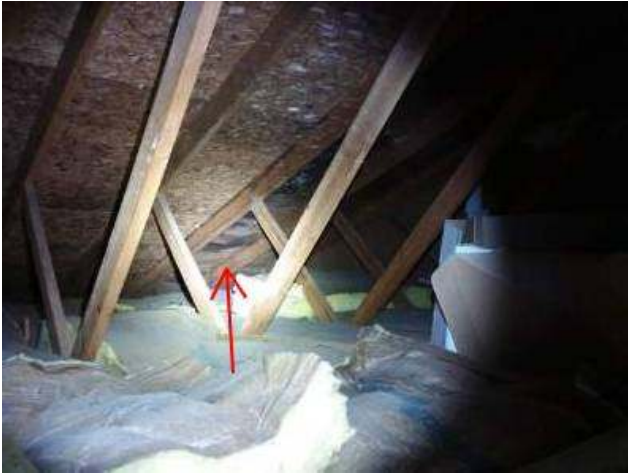
8) Monitor, Comment - Evidence of previous water infiltration on roof sheathing at front of house.

Photo 8-1 Evidence of previous water leak.

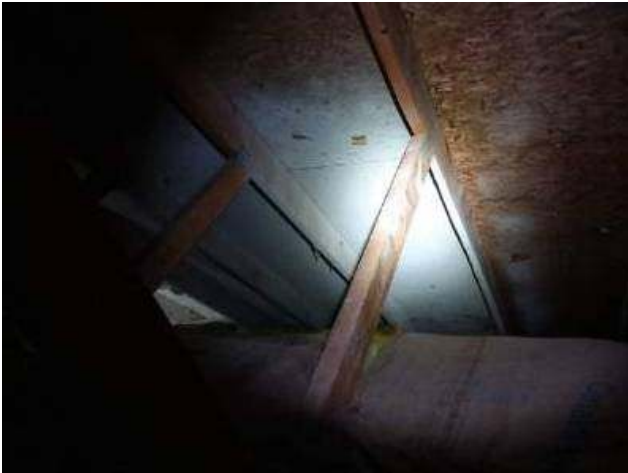
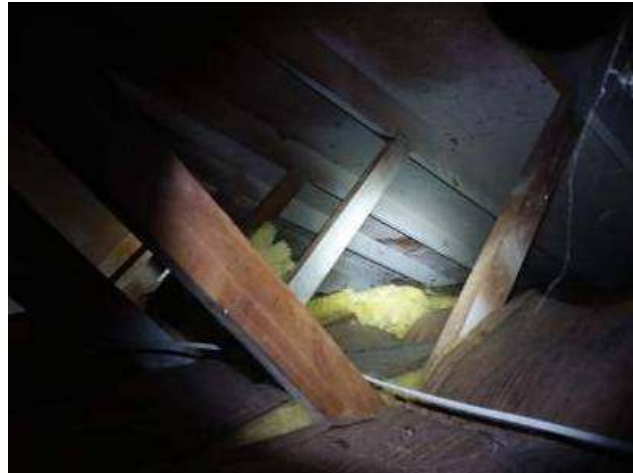
9) **Monitor, Comment** - Evidence of paint on sheathing in attic at rear of house-possible repair of organic growth.

Photo 9-1 Evidence of repair; may be treatment for organic growth.

Photo 9-2 Evidence of repair; may be treatment for organic growth.

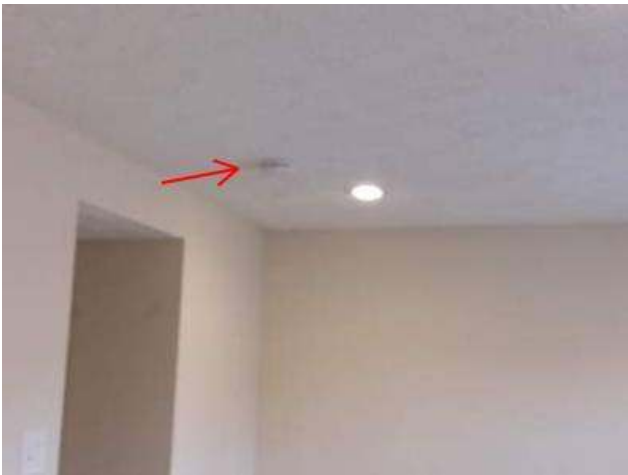
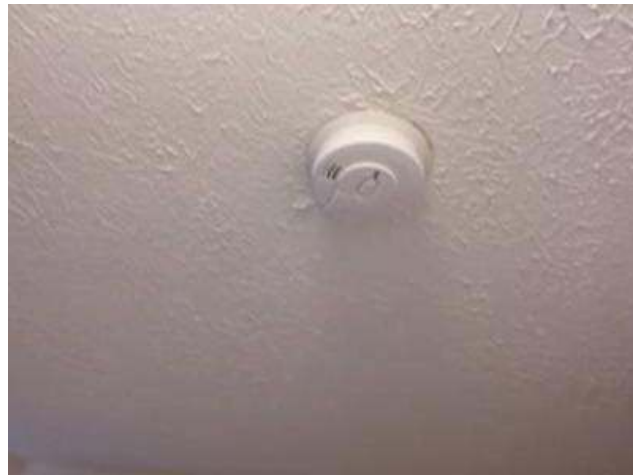
One smoke alarm was present on each floor. The 1st floor smoke detector was located in the family room and was a sealed 10 year battery non-hardwired type. The 2nd floor smoke detector was located at the top of the stairs and was a hardwired type. They were not interconnected. No smoke detectors in any bedrooms.

Photo 11-1 1st floor 10-year sealed battery non-hardwired smoke detector.

Photo 11-2 2nd floor hardwired smoke detector.

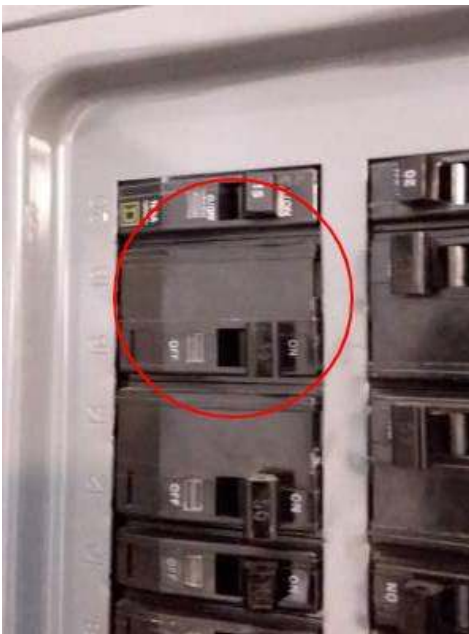
12) **Safety, Repair/Replace** - Outdoor condenser has max breaker of 20 Amps-panel has 30 Amp.

Photo 12-1 30 AMP breaker for HVAC compressor. Compressor rated for 20 AMP.

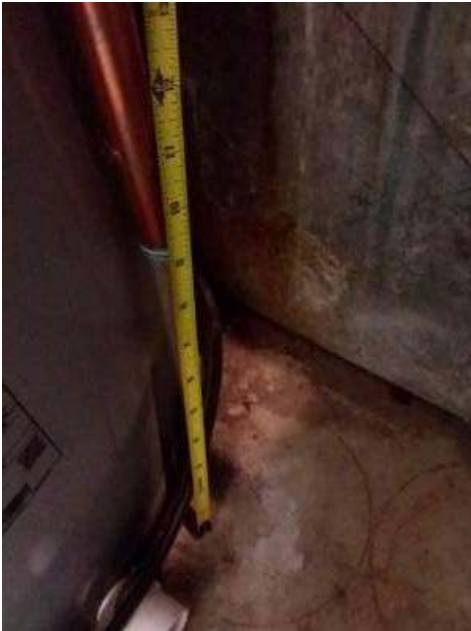
Photo 15-1

15) **Repair/Replace** - TPR valve drain pipe terminated >6" from the floor; recommend replacement.

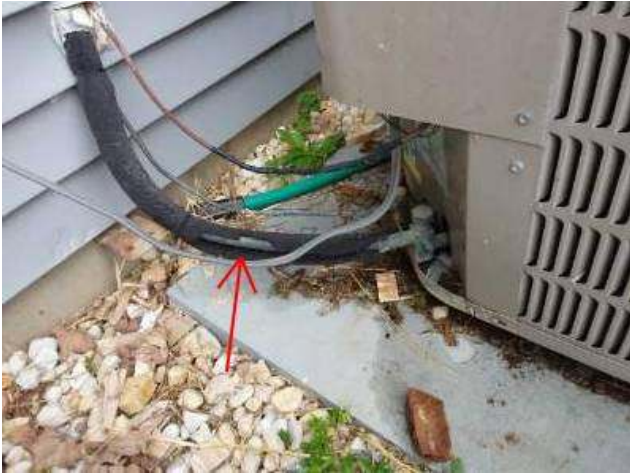
18) **Repair/Replace** - Insulation on the heat pump or air conditioning condensing unit's refrigerant lines was deteriorated or missing in some areas. This may result in reduced efficiency and increased energy costs. Recommend that a qualified person replace or install insulation as necessary.

Photo 18-1 Degraded HVAC line insulation needs replacing.

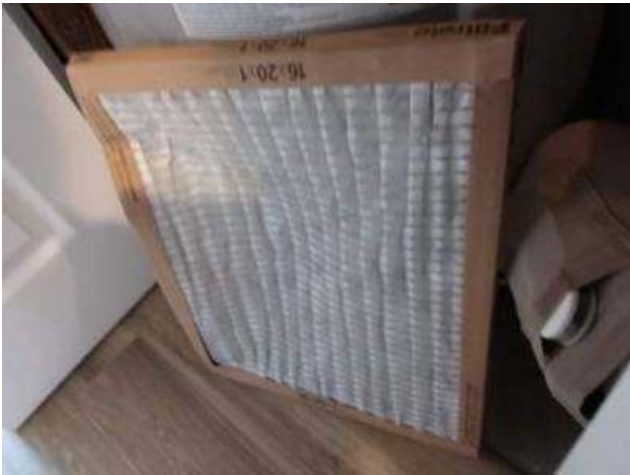
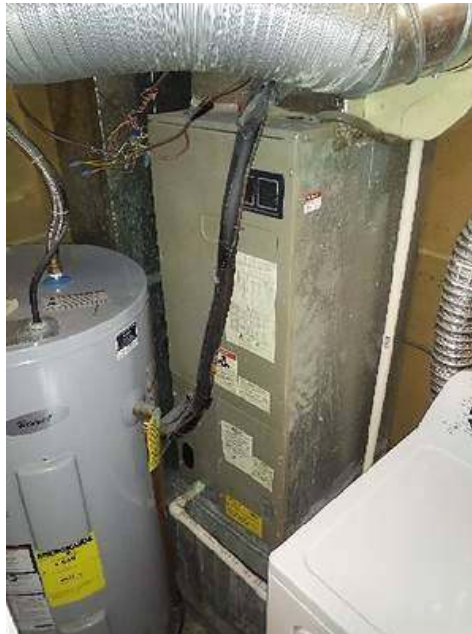
19) Repair/Maintain - The water heater is installed too close to the air handler preventing access to the filter slot. Filter must be forced in to install. This has limited service to the unit.

Photo 19-1 New filter ruined during install/removal. No clearance to filter slot resulting from installation of water heater too close to air handler.

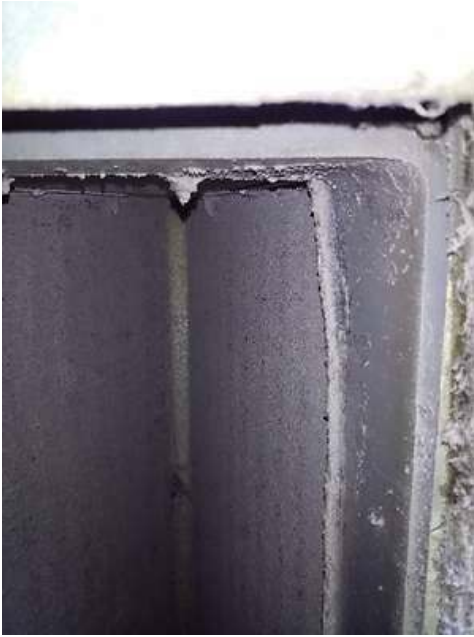
Photo 20-1

20) Repair/Maintain - Coils in air handler were dirty and in need of service. Recommend a complete service by a qualified HVAC contractor.

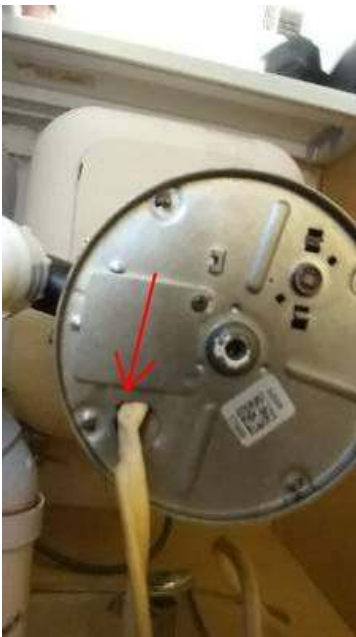
23) **Safety, Repair/Replace** - Electrical wiring for the under-sink food disposal was substandard. Non-metallic sheathed wiring was exposed and subject to damage. The wiring can be damaged by repeated bending or contact with sharp objects. BX-armored conduit should be installed to protect wiring, or a flexible appliance cable should be installed. This is a potential shock hazard. Recommend that a qualified contractor repair per standard building practices.

Photo 23-1 Missing wire clamp.

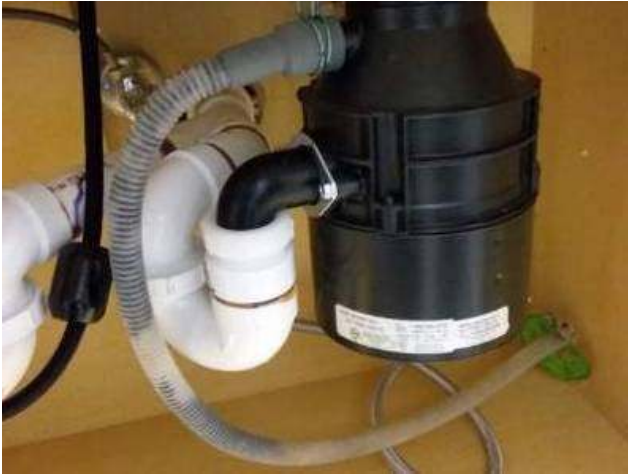
dishwasher if/when a siphon occurs. Some newer dishwashers have these devices built in. Recommend reviewing the dishwasher's installation instructions, consulting with the property owner and/or having a qualified contractor evaluate further to determine if a high loop and air gap are installed or needed. If not installed, and none is built into the dishwasher, then recommend that a qualified contractor install a high loop and air gap per standard building practices.

Photo 25-1 No evidence of high loop for dishwasher.
