Kyawa OC Services

Property Inspection Report

Inspection date: Friday, April 12, 2019

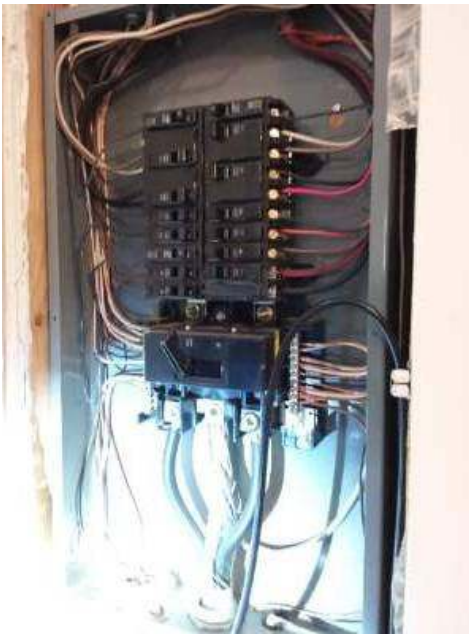
Photo 13-1

13) - Electric panel.

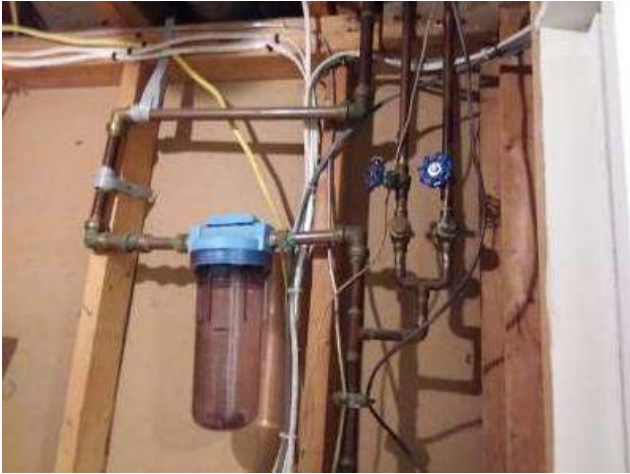
Photo 14-1

14) **Evaluate** - A water filtration system was installed on the premises. These are specialty systems and are excluded from this inspection. Comments in this report related to this system are made as a courtesy only and are not meant to be a substitute for a full evaluation by a qualified specialist. Filter cartridges typically need replacing periodically. Cleaning and other maintenance may also be needed. Recommend consulting with the property owner about this system to determine its condition, required maintenance, age, expected remaining life, etc. For more information, visit:
